DAMAGE ASSESSMENT FORM

Building Name KROME RESIDENCE

Address 17845 S.W. 296 STREET

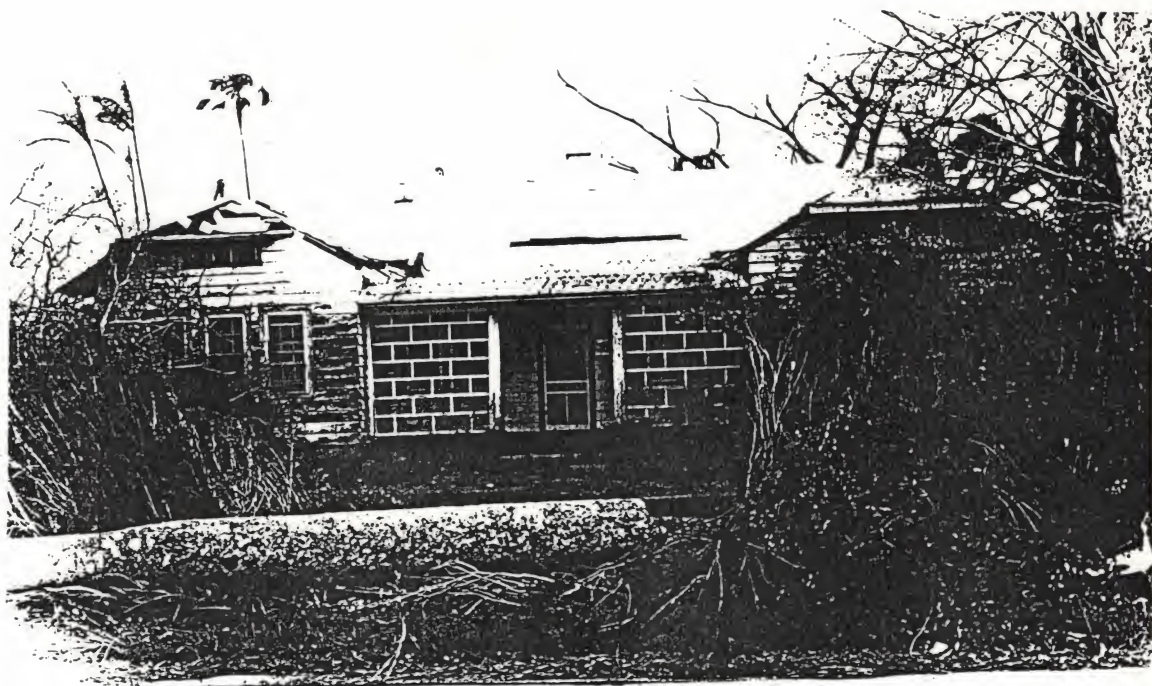
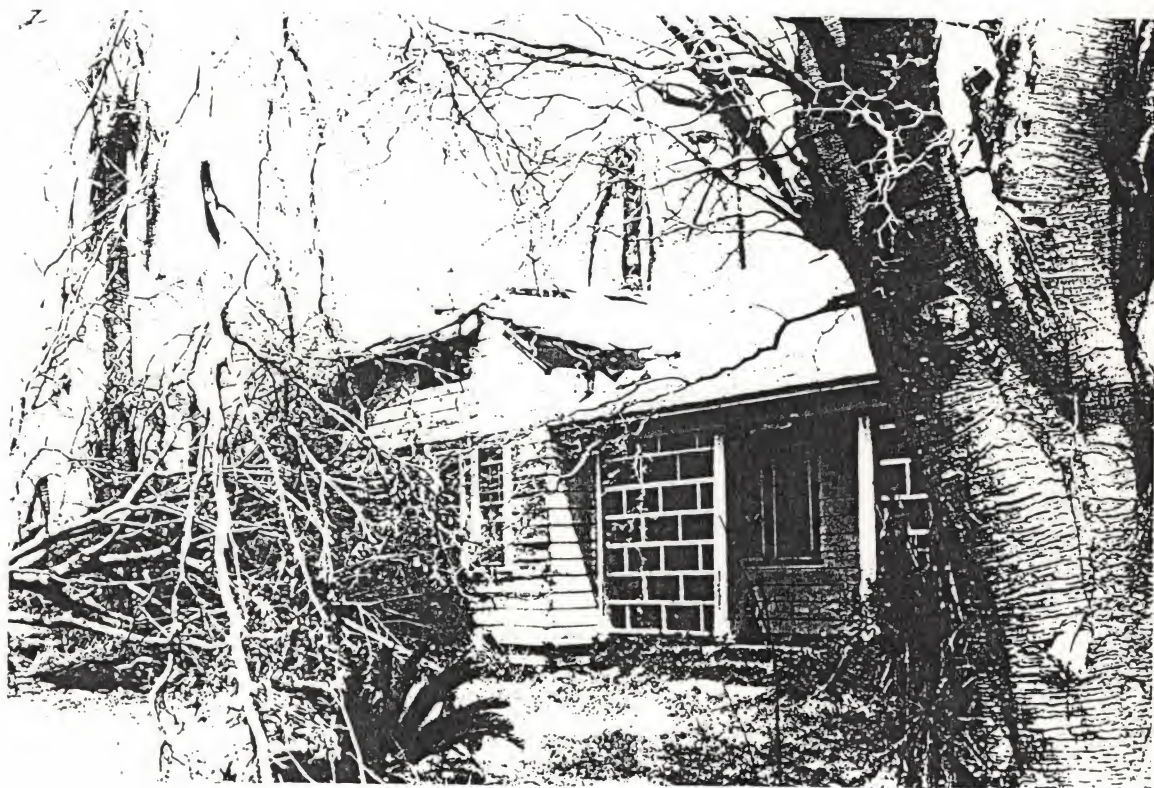
KROME

%	Comments
Exterior Walls	1	
Frame (General Condition)	0	
Frame Members	0	
Frame Connections	0	
Roof Framing	1	
Roof Covering	20	
Foundation	0	
Chimney(s)	0	
Doors	0	
Windows and Shutters	1	
Porch	0	
Downspouts and Gutters	NA	
Interior Bearing/Shear Walls	0	
Partitions (Nonbearing)	1	
Floor(s)	1	
Stair(s)	NA	
Glass	1	
Mechanical Equipment	NO	
Electrical Equipment	NO	
Garden and Trees	40	
Fences and Garden Walls	NA	
Walkways and Sidewalks	0	
Other: <u>Driveway(s)</u>	30	<u>Rock Damage</u>
Total Damage	15%

Recommendations for Immediate Stabilization ROOF IS CURRENTLY
LEAKING

Recommendations for Immediate Actions ROOF NEEDS TO BE REDONE

Recommendations for Future Repair Work CEDAR SHAKES WILL NEED TO
BE REMOVED BEFORE METAL TILE WILL BE ABLE
TO BE REPLACED; ^(Interior) CONCRETE WALLS WILL NEED
SOME TREATMENT
